# FORM B – BUILDING

Town SOUTHBOROUGH

Address 21 Richards Road

Historic Name Nathan Works (1857)

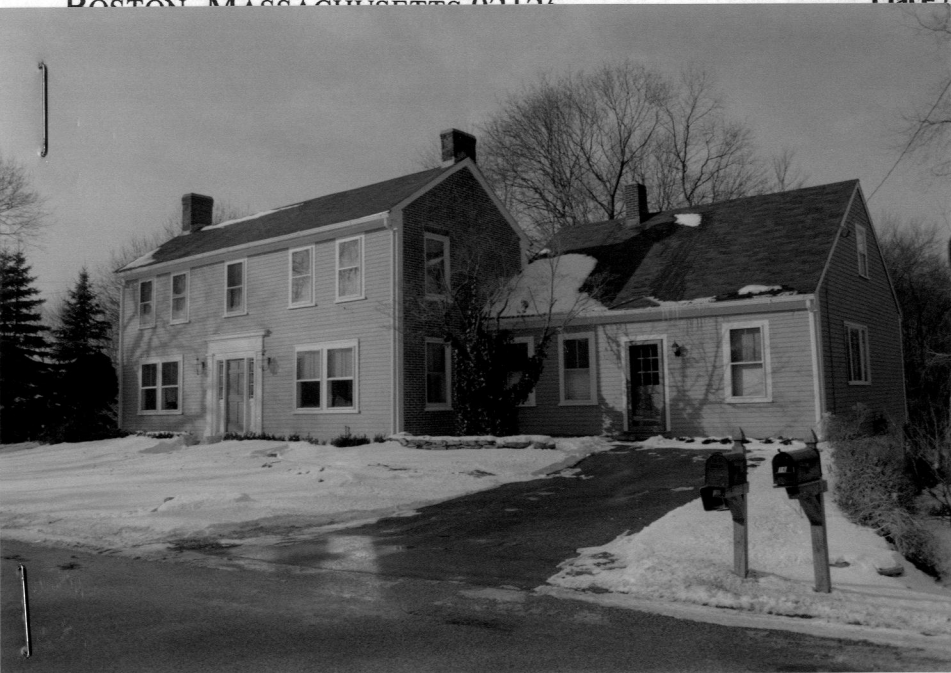
One of the oldest dwellings in the south part of Southborough is this two story, five-bay, late eighteenth century dwelling that essentially has been rebuilt in the 1990s. The dwelling is two bays deep and is one of three or four Southborough houses with brick ends. Windows in the brick ends are set in wood sash that are recessed into brick and have splayed lintels of brick. Windows have been altered and now have two-over-one sash with a combination storm and screen window and a plain frame. First-story windows on the main facade flanking the center entrance are large paired sash set in a single frame with a molded strip framing the surround. The Greek Revival centered entrance displays a six-paneled door with flanking half side lights set in a frame with plain pilasters carrying a wide entablature with molded lintel. The twin ridge chimneys on the main block are set just inside the gable end walls. The one-story side ell, which traditionally is thought to have been a school moved here, has four bays including three two-over-one windows and an entrance with a multi-light and paneled door. One ridge chimney is over the second bay from the left. In the gable end of the side ell there is a single window in the peak and a modern three-part window at the first story level. The trim is limited to narrow corner boards and narrow fascia board that are covered by the modern aluminum gutters and down spouts. There is virtually no eave overhang and no returns in the gable ends.
