| Historic Name: | Ward, Lyman House |
| Address: | 211 Middle Rd |
| City/Town: | Southborough |

FORM B – BUILDING

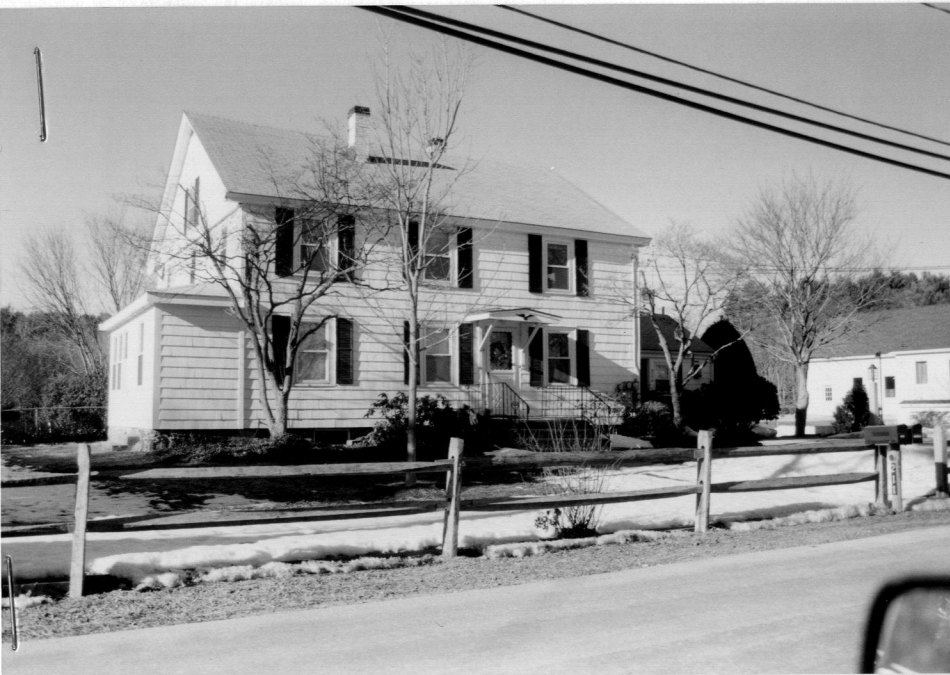
Major Alterations (with dates) vinyl windows and shutters, shingle siding, additional enclosure of southwest side porch, northeast side extension, demolition of barn - 1990s.

Condition fair

Although altered this property is one of only a few known pre-1830 extant properties in the southern part of Southborough. The side gable two and one-half story house displays three evenly spaced window bays up and down on its main facade with an entrance bay between two of the bays. The entrance is awkwardly located and due to the modern door and make-shift doorhood does not appear to be part of the original construction. One narrow chimney is located below the ridge on the east roof slope between the first and middle bays, while a second chimney protrudes from the west or rear roof slope below the ridge between the middle and third bay. The southwest gable end of the house displays a slight gable peak overhang with a fairly wide rake and no returns, one window in the gable peak, three second story windows, and an enclosed one-story rectangular porch with vinyl windows. 1970s photographs show an enclosed porch with windows on all sides and an entrance door. This has been substantially modified. The side addition on the northwest side has five one-over-one vinyl windows, a side entrance door and an exterior chimney. The large attached barn shown in 1970s photographs has been demolished.

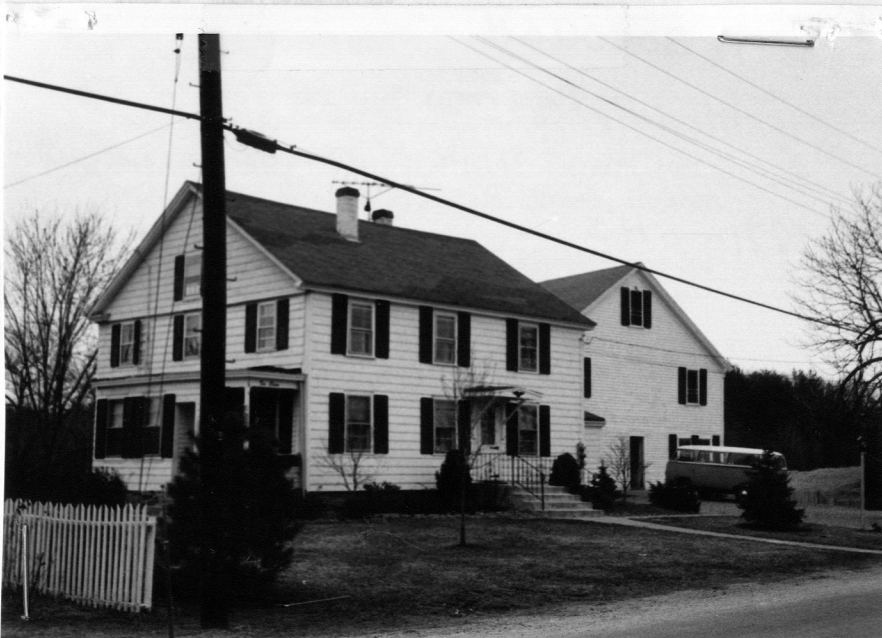
Photo # 5-24 Date 1971

1. Outbuildings attached Barn
