Inventory No:	SBR.85
Historic Name:	Walker, Peter - Donahue, John House
Common Name:	Colleary, William House
Address:	116 Framingham Rd
City/Town:	Southborough
Village/Neighborhood:	
Local No:	75-37
Year Constructed:	r 1870
Architect(s):	
Architectural Style(s):	No style
Use(s):	Agricultural; Poultry Farm; Single Family Dwelling House
Significance:	Agriculture; Architecture
Area(s):	
Designation(s):	
Building Materials(s):	Roof: Asphalt Shingle Wall: Asbestos Shingle; Wood Foundation: Stone, Uncut; Concrete Cinderblock

FORM B - BUILDING

116 Framingham Road

Walker/Donahue House

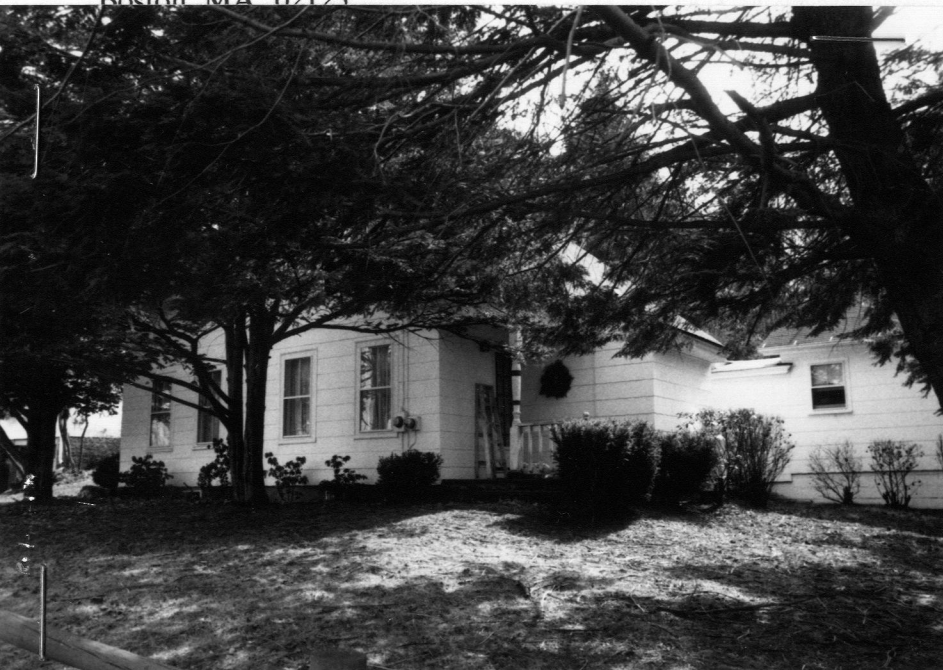
This two-story, cross-gabled house stands with its main roof ridge parallel to the street, with its entry in the north, cross-gabled portion under a corner porch sheltered by the extended overhang of the north roof slope. Behind the entry is a shallow, flat-roofed north ell; beyond that the cross-gabled portion continues to the rear, where a low addition connects to a long, gable-roofed 1 1/2-story twentieth-century wing on a concrete block foundation. A one-car garage occupies the basement story of the wing.

Four bays of 2-over-2-sash windows with molded surrounds occupy the east, street side of the main house. The entry in the north end has a multi-light twentieth-century door; the corner of the roof overhanging the entry porch is supported on a turned post. The garage door in the north end of the wing is a mid-twentieth-century panel-and-glass overhead type.

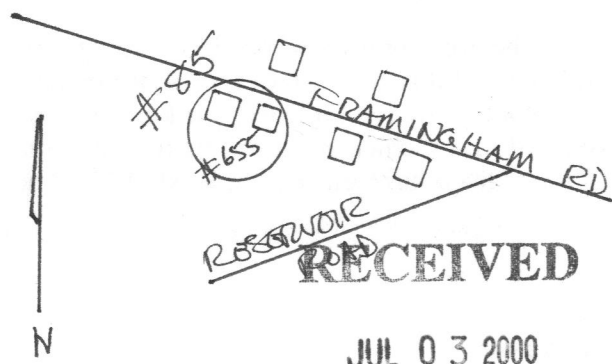
Sketch Map

Setting On long through-street; new houses to S.,
 orchard to rear. Mature hemlocks in front; garden
 to N. Split-rail and board fences.
