Inventory No:	SBR.219
Historic Name:	Newton, Ephraim - Stow, Benjamin House
Common Name:	
Address:	14 Oregon Rd
City/Town:	Southborough
Village/Neighborhood:	
Local No:	15-9
Year Constructed:	c 1720
Architect(s):	
Architectural Style(s):	First Period; Georgian
Use(s):	Agricultural; Single Family Dwelling House
Significance:	Agriculture; Architecture; Exploration Settlement
Area(s):	
Designation(s):	
Building Materials(s):	Roof: Asphalt Shingle Wall: Wood Clapboard; Wood Shingle; Wood Foundation: Stone, Uncut

FORM B - BUILDING

s 14 Oregon Road

c Name Benjamin Stow House

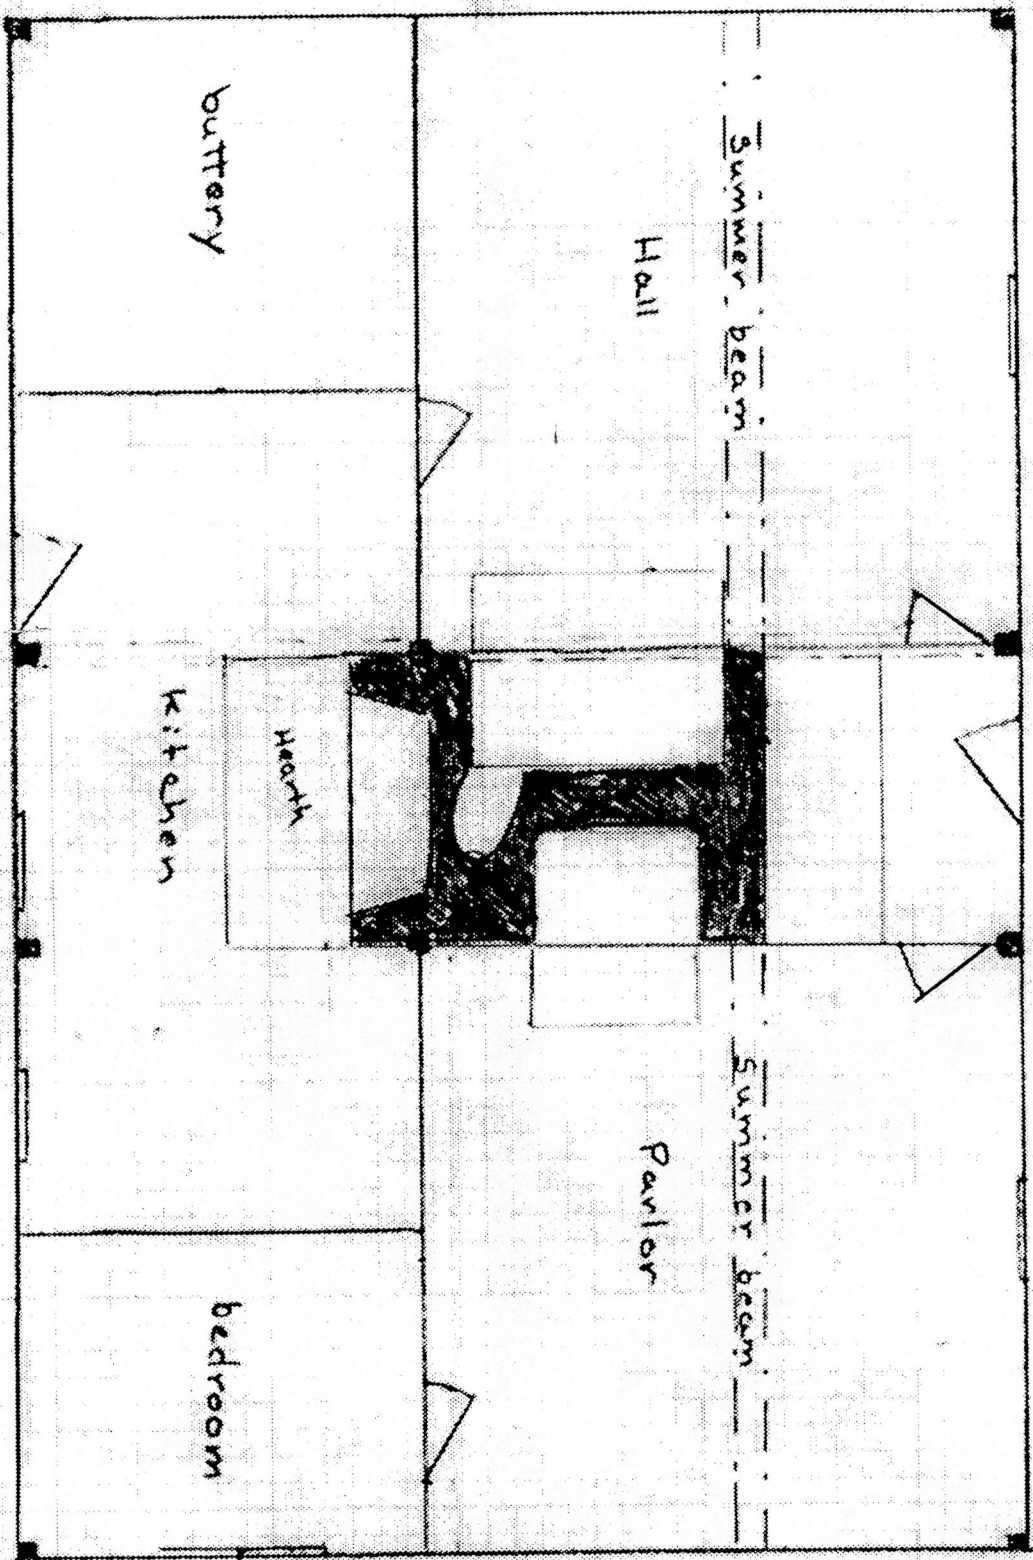
Ephraim Newton house
Proposed original floor plan
14 Oregon Rd Southboro Ma.

* Chimney based on conjectural Reconstruction

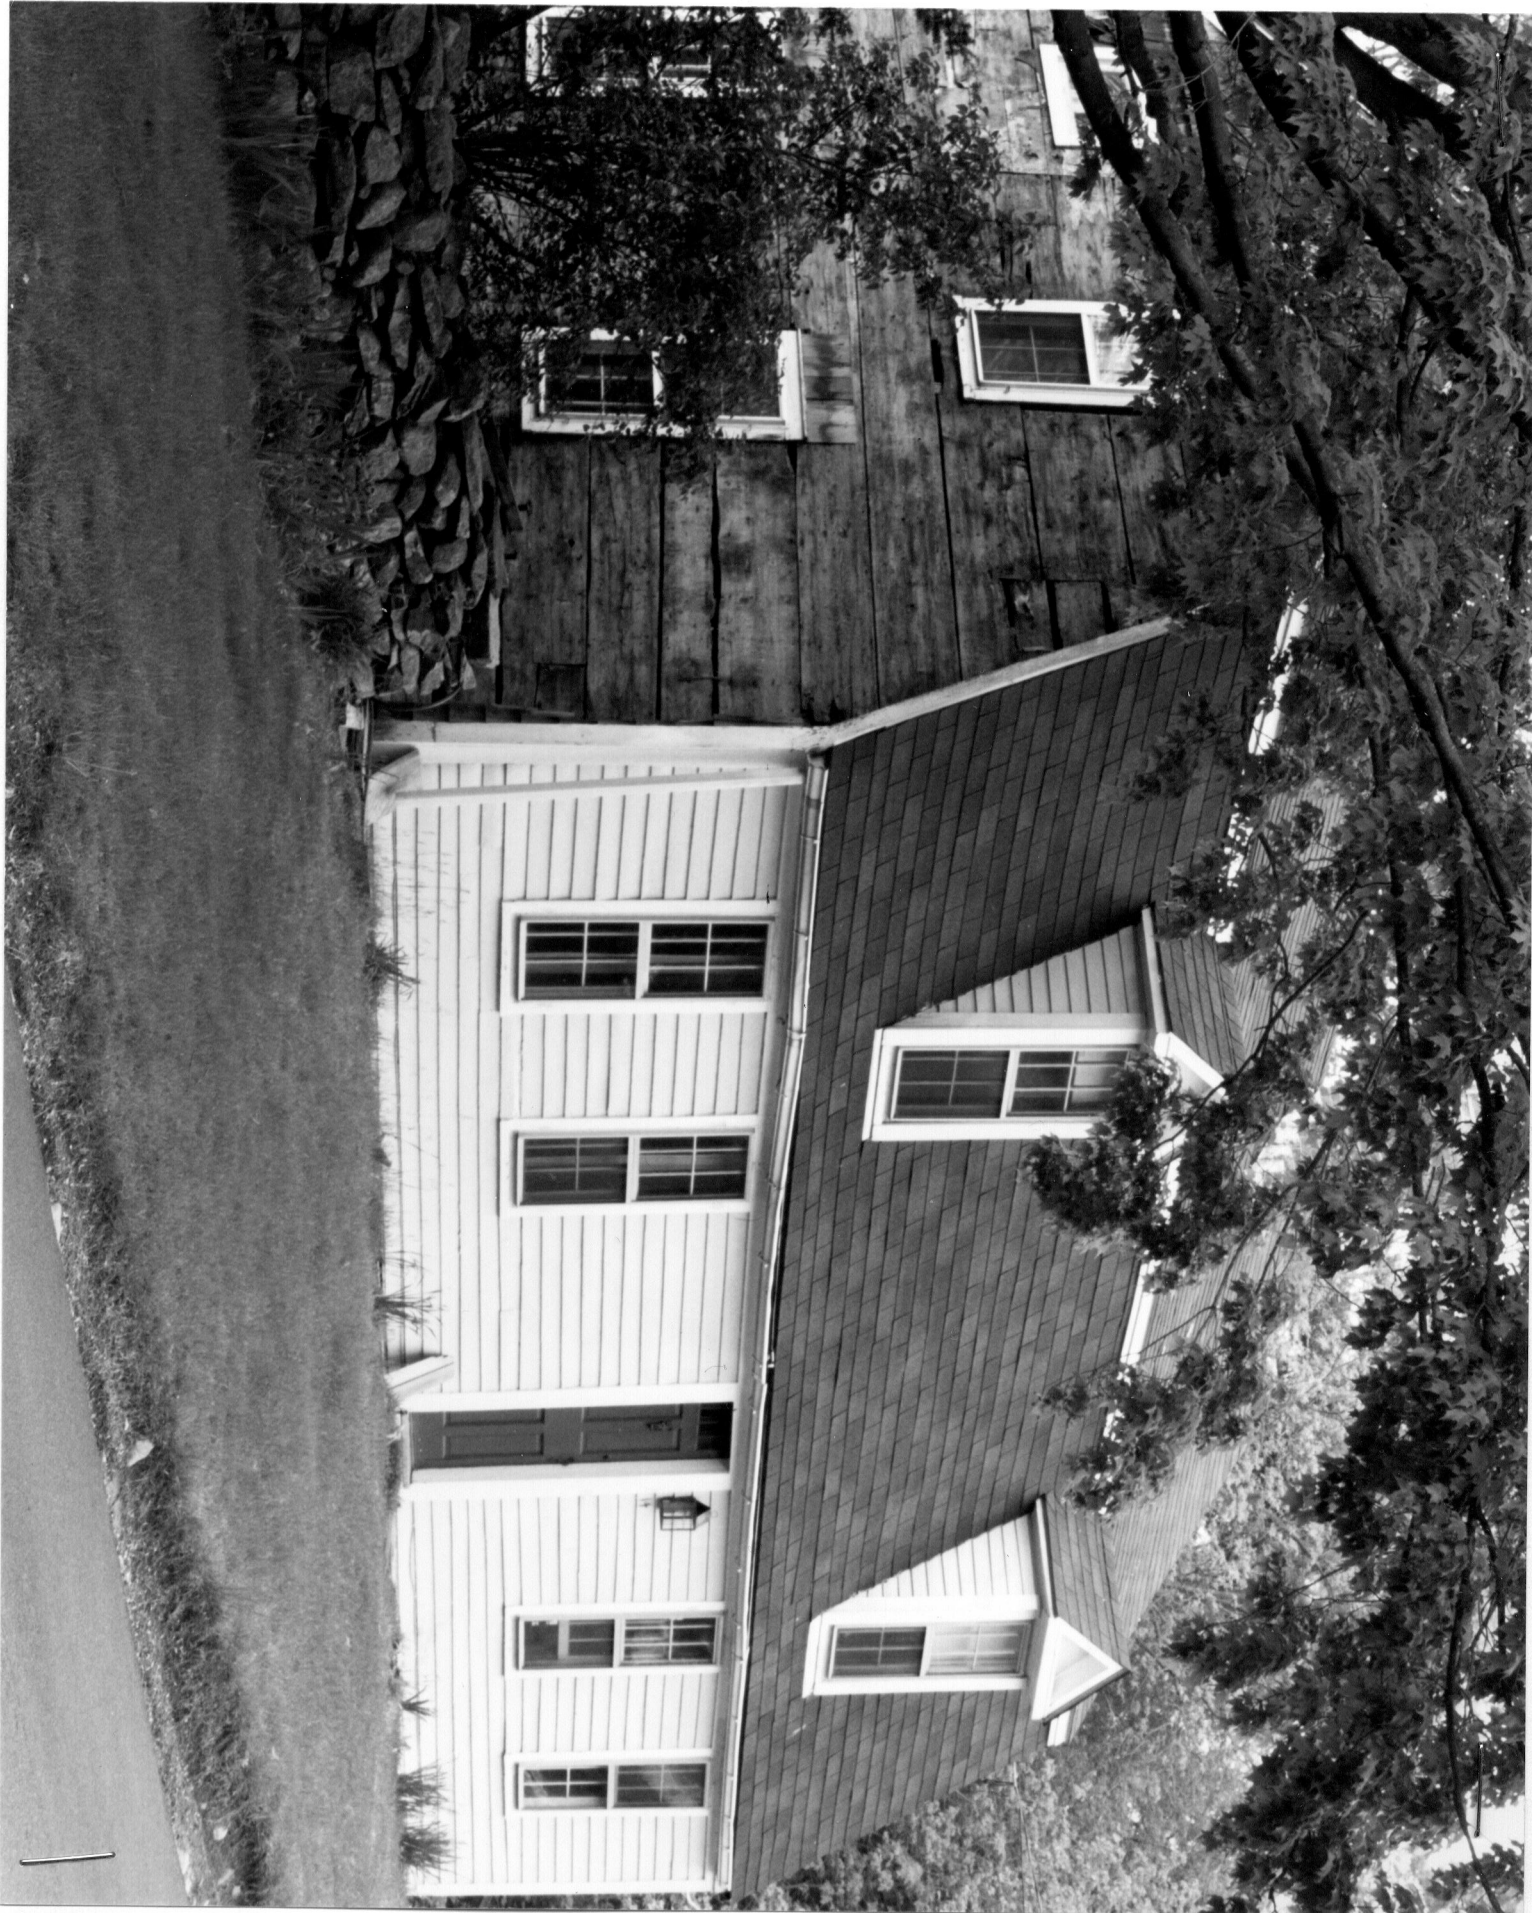
Large
photo
#1

South and east elevations of house including ell,
wood shed, workshop and west bay of barn

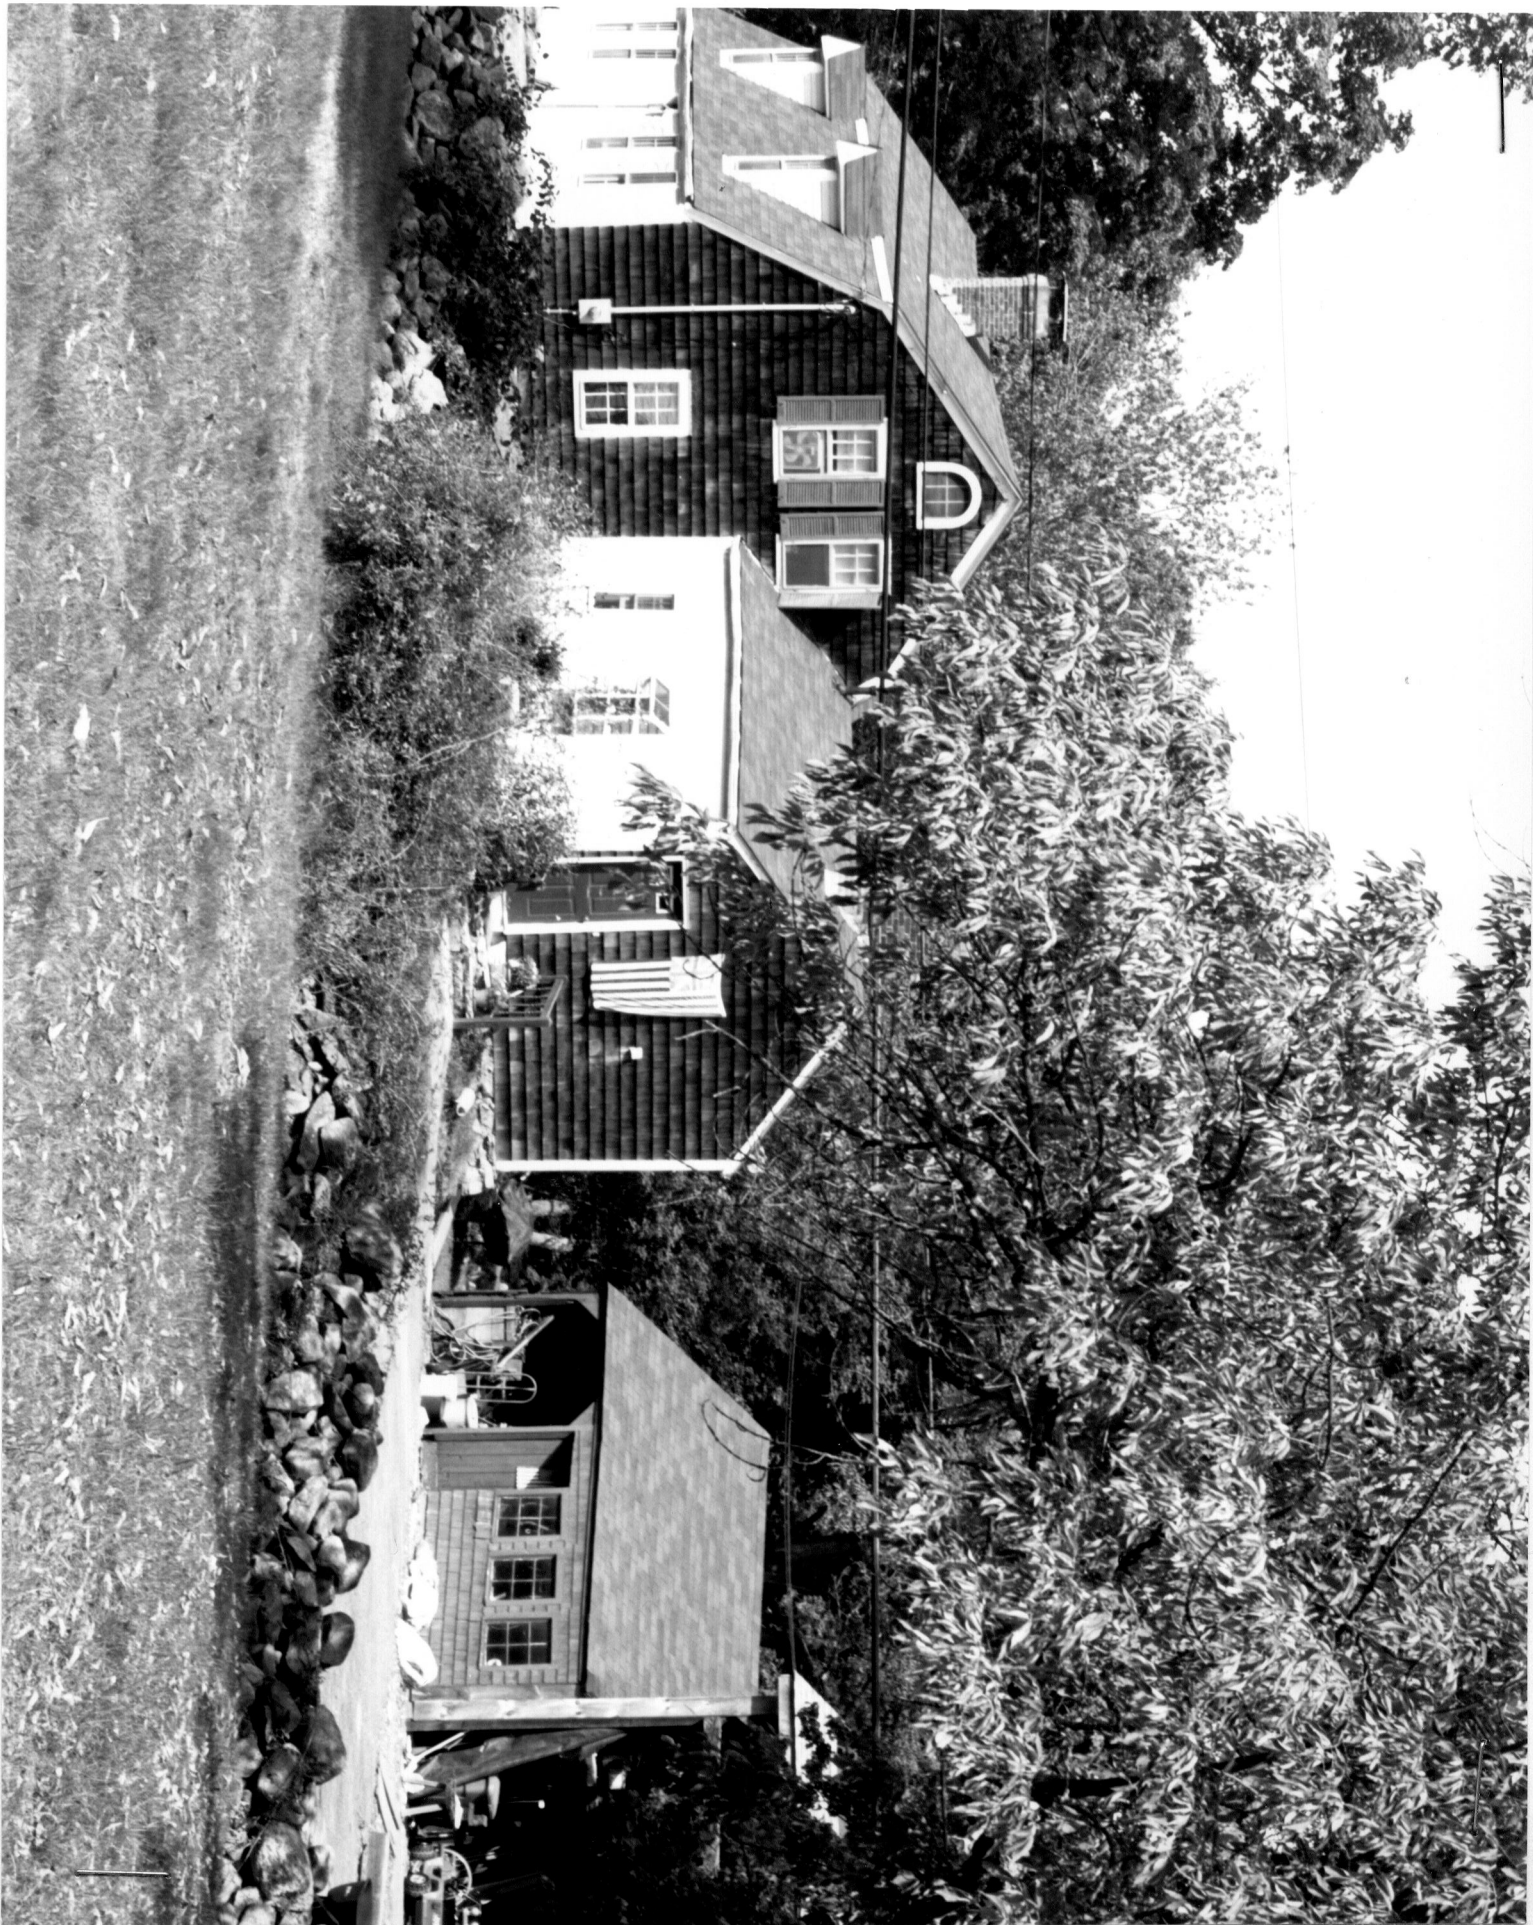
Large
Photo
#2

South and west elevations of house during residing of west-end.
with heavily weathered board sheathing exposed.

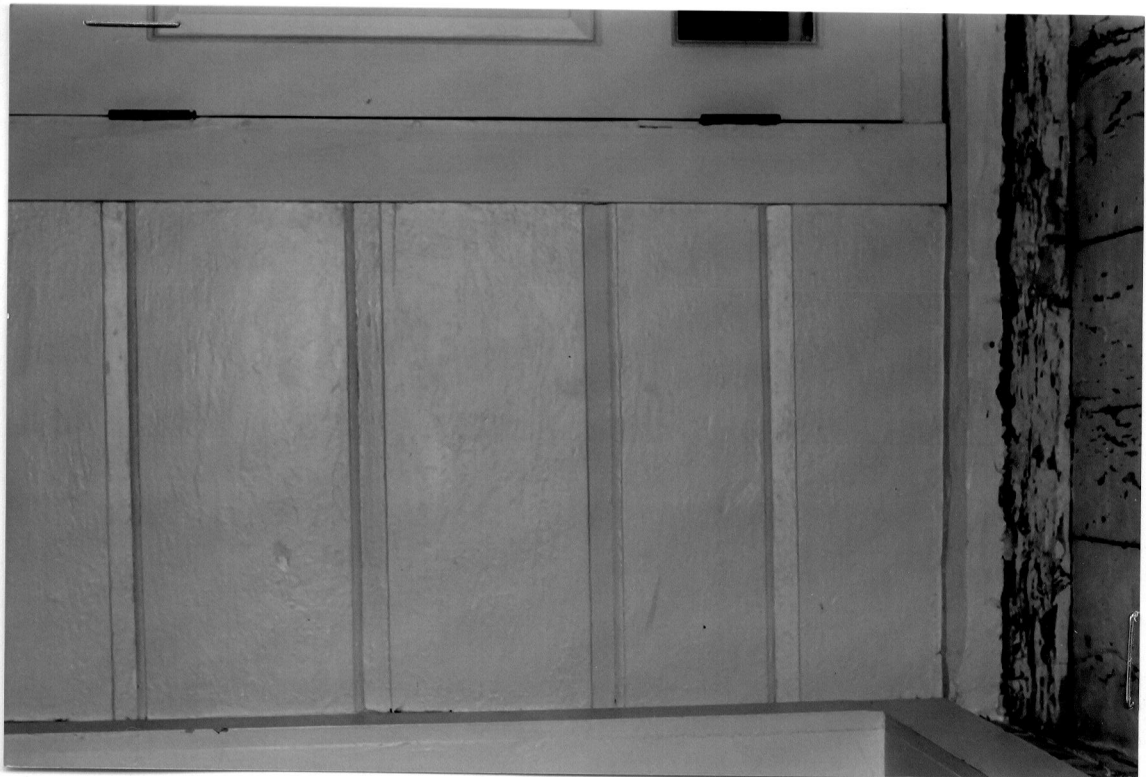
Main house - Front entry
horizontal panel on exterior
wall. note early white wash on
plate and sub floor above

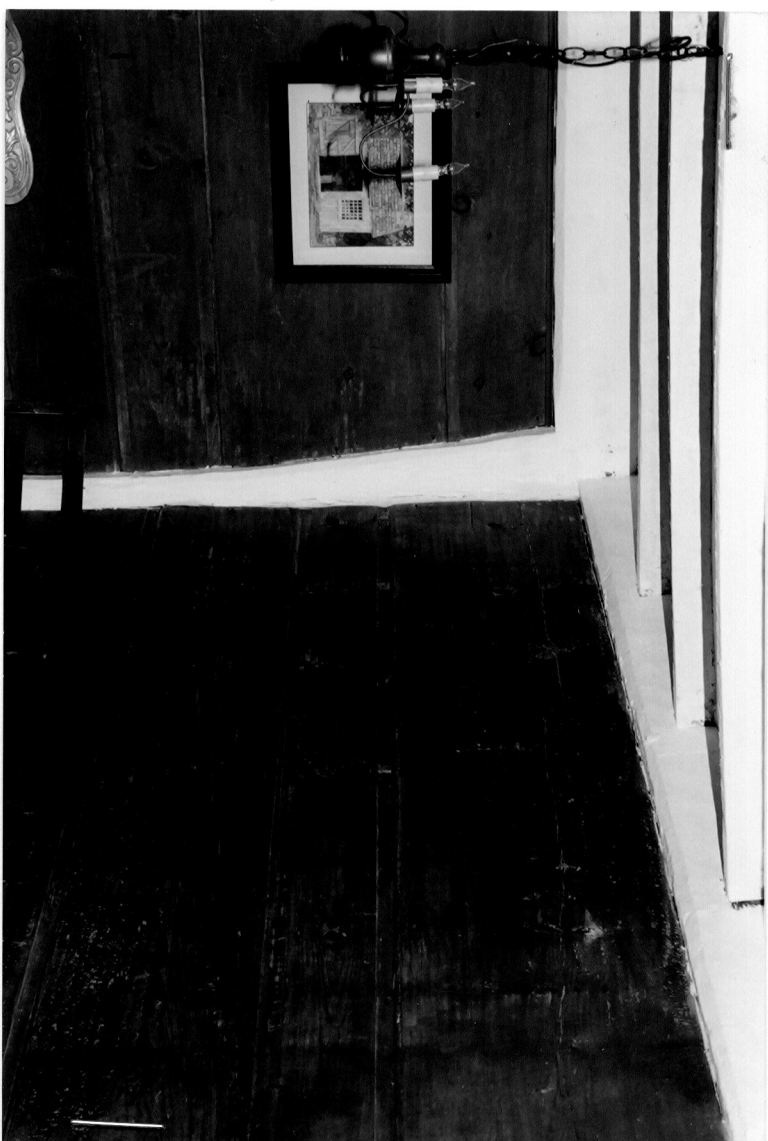
Main house
NW corner intersection of north plate,
west end girt and corner post. original
horizontal feather edge panel.

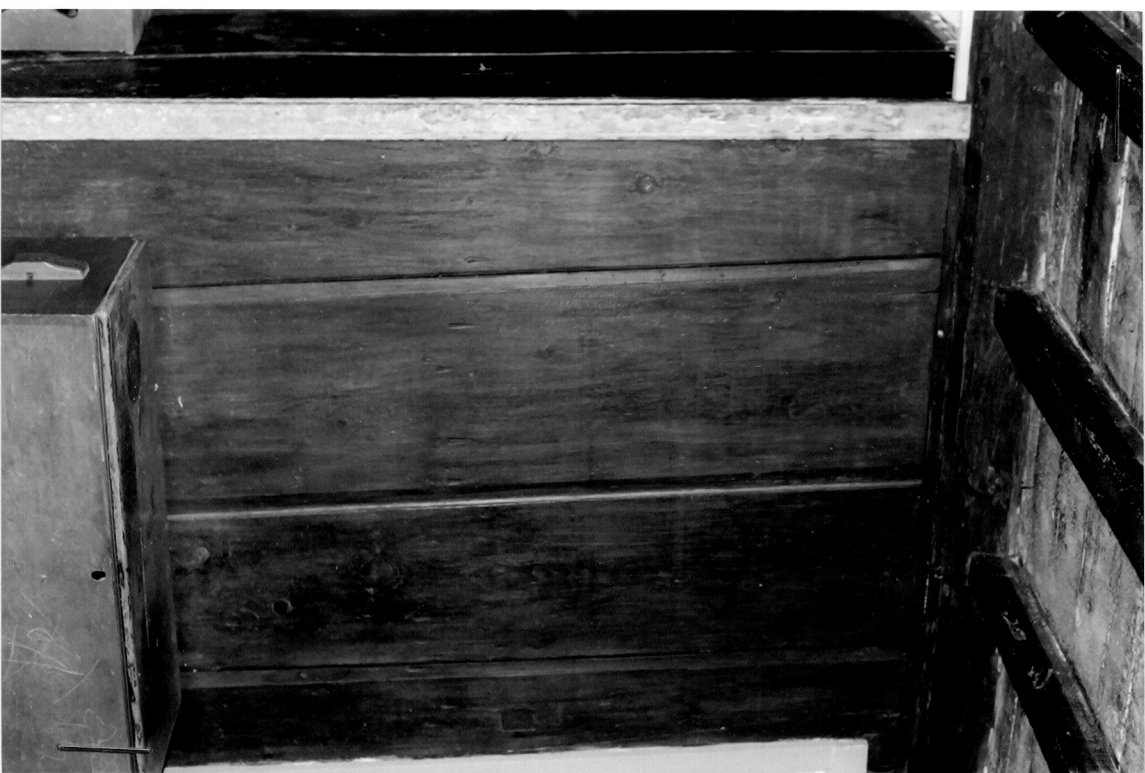
Main house SE Room 1st floor
 north wall - vertical feather-
 edge board wall. in original
 position _____

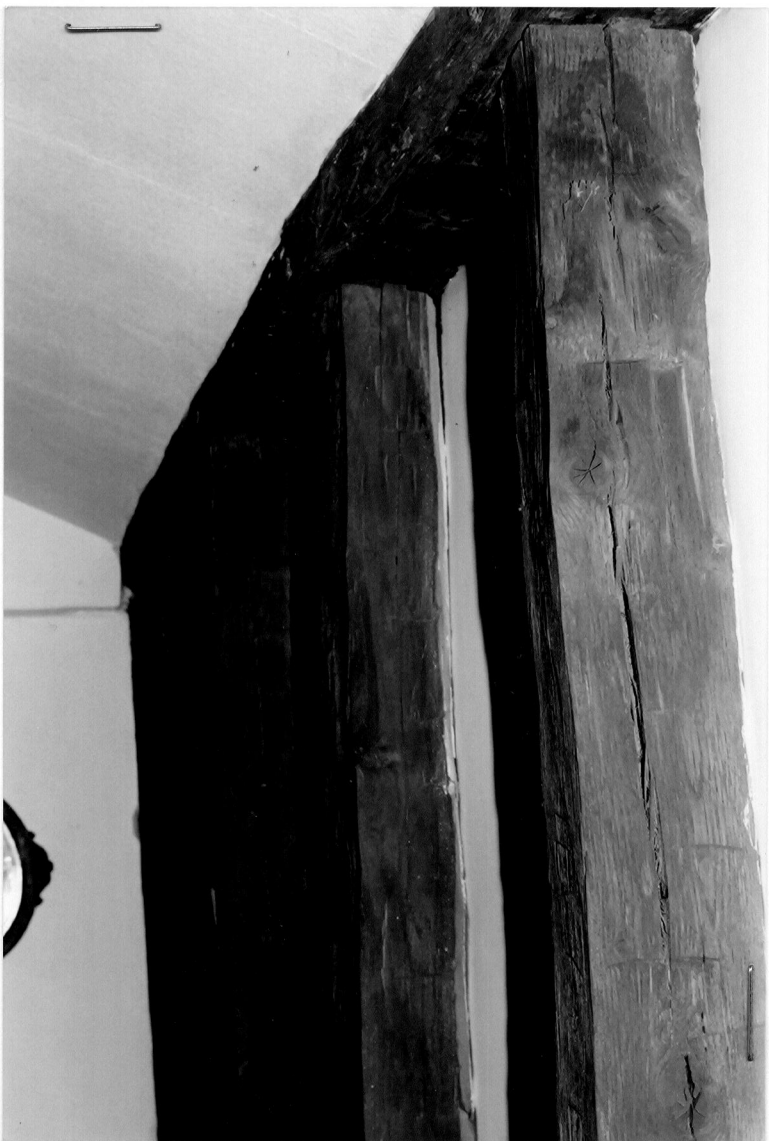
Frame - 2nd floor ceiling joists intersecting
South parlin

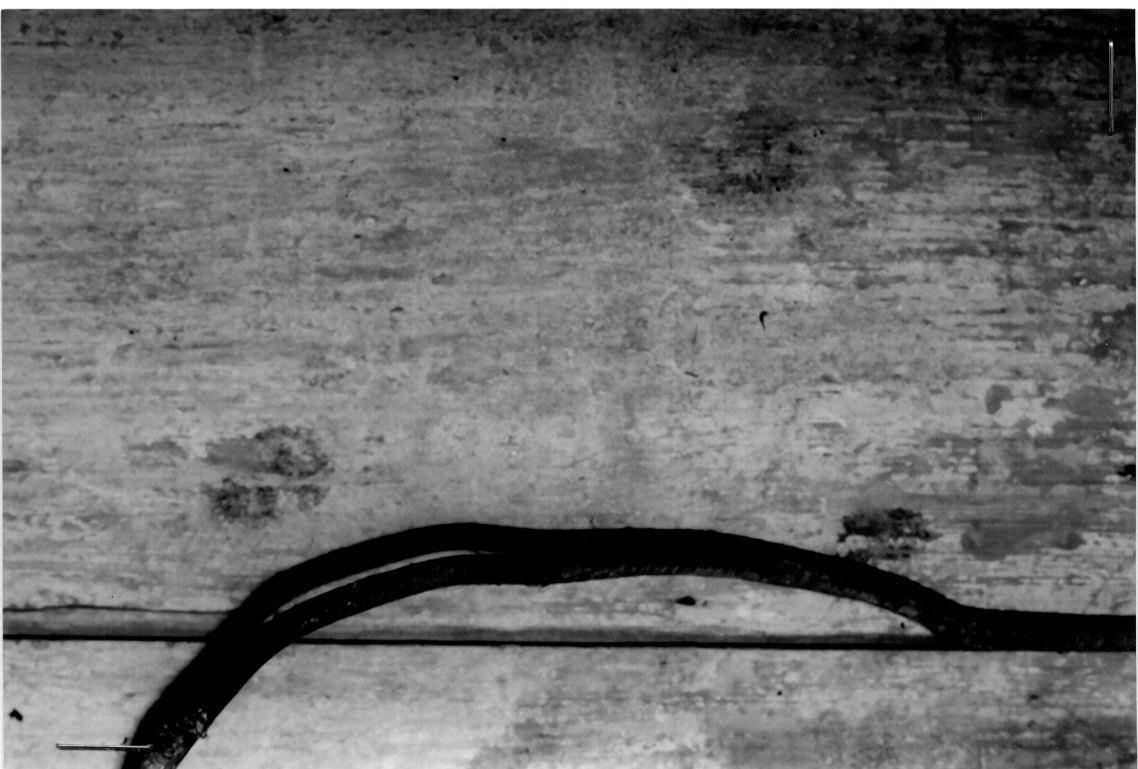
Main house - basement stairwell
back side of SE room north
wall (vertical feather edge panel)
Random polka dot over whitewash.
This room was apparently
originally a battery.

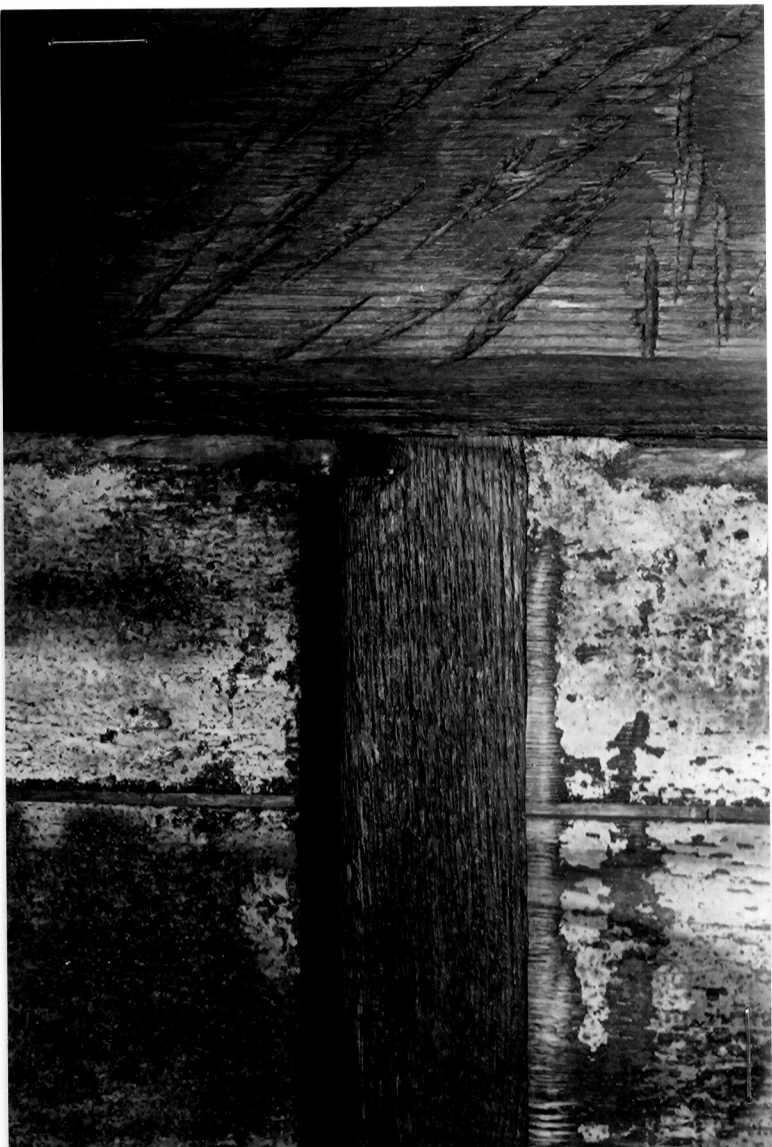
main house - SE Room - ceiling
intersection of middle joist with half dovetail
and summer beam
note: early whitewash on sub floor

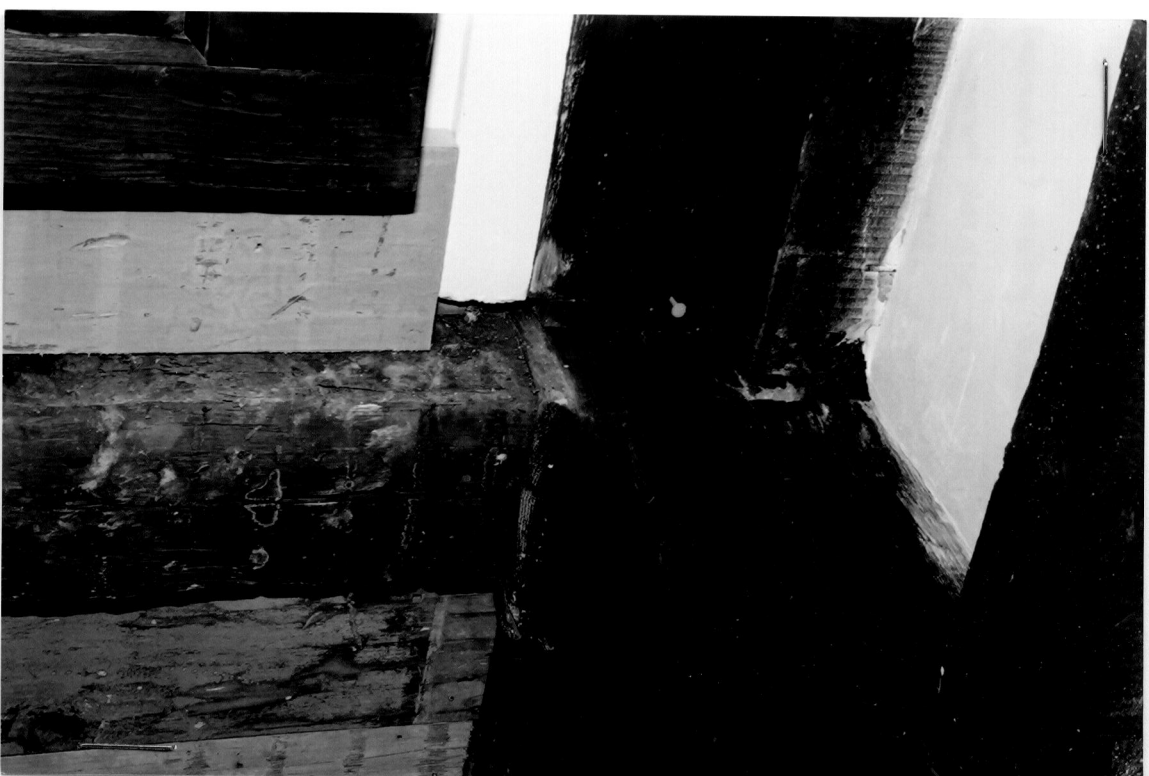
main house kitchen
chimney girt and post (interior)
note step of girt which runs
from front to back of house

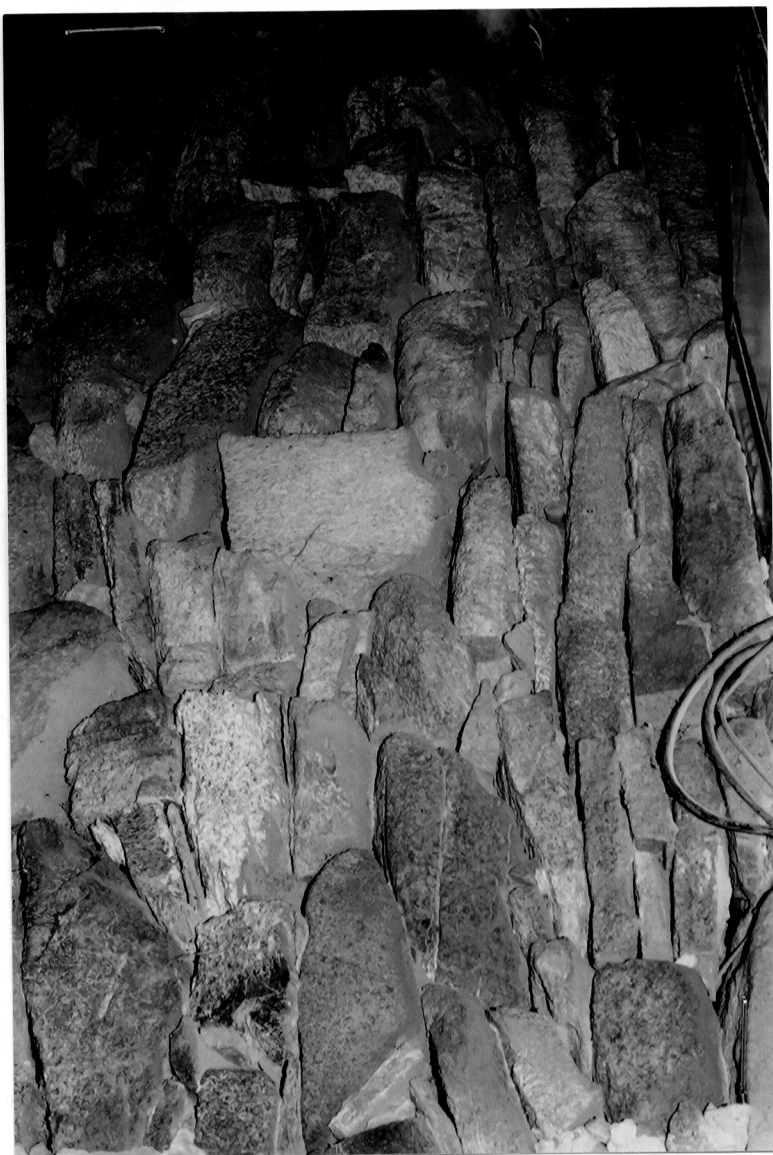
Main house - basement
dry laid stone foundation

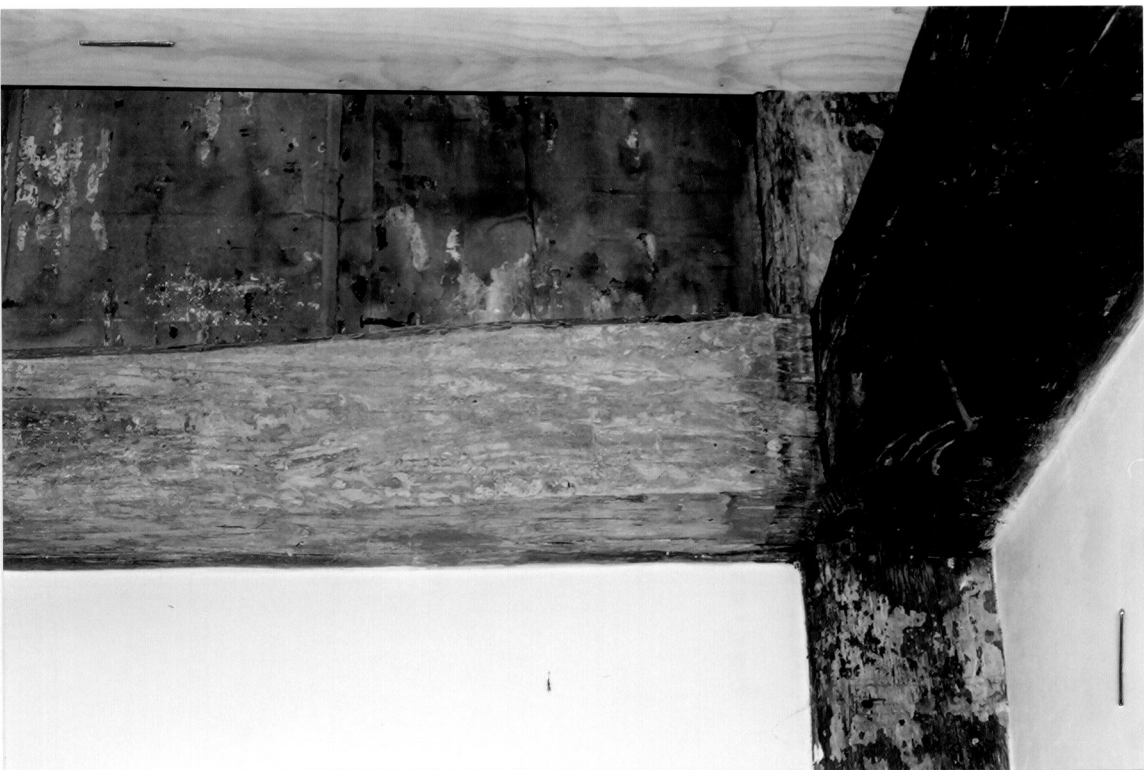
main house kitchen
intersection of Plate, chimney
girt and Post. note chamfers
and stops, early whitewash
on plate, salmon colored paint
(ever whitewash) on original
horizontal feather edge panel.

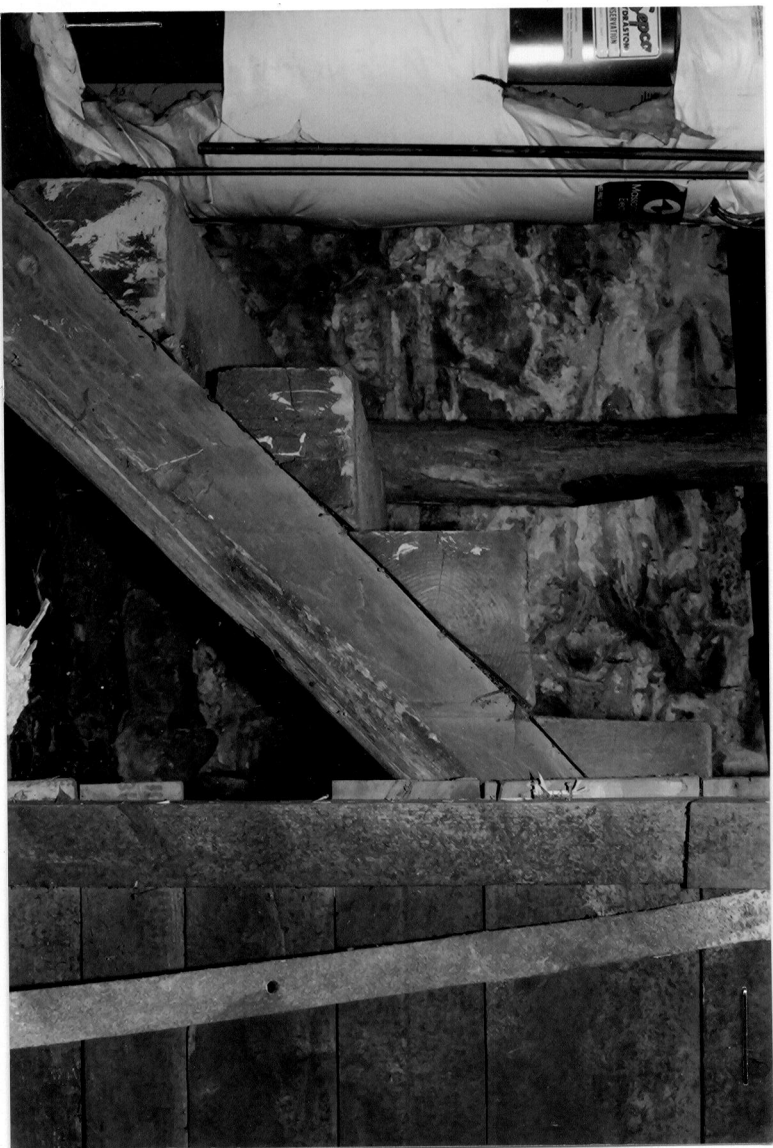
Main house - basement
triangular log stairs - This location was
19th - may have been moved from ^{earlier} original location
