FORM A - AREA

Town SOUTHBOROUGH

Name of Area Woodland Road at Oregon Road

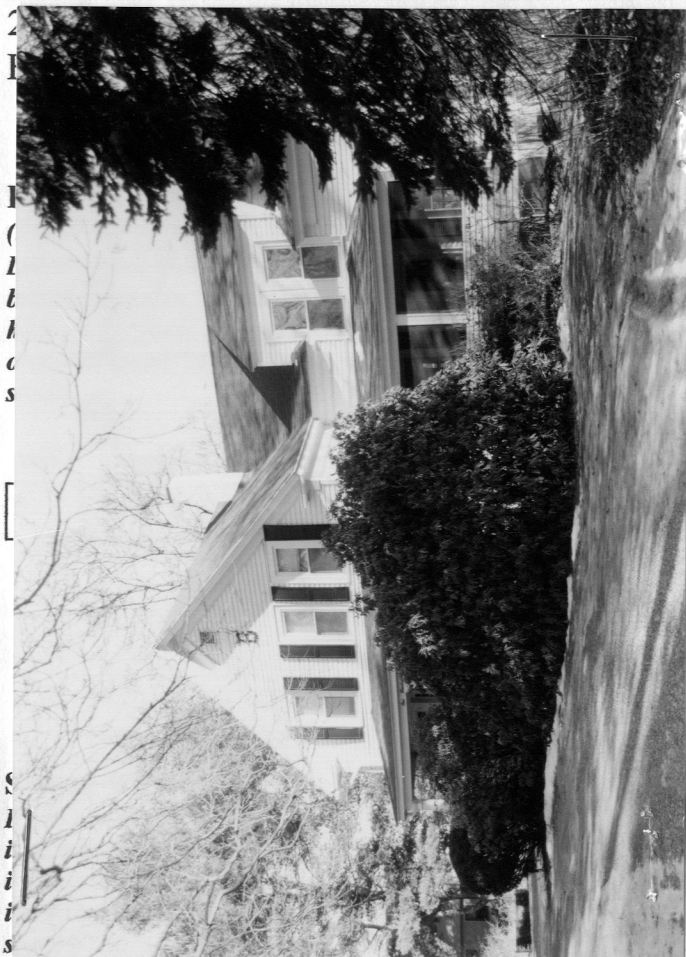
628-630

MHC # 628 133 Woodland, ca. 1920s, rests on a stone and mortar foundation, has asbestos shingle siding and an asphalt roof. The two and one-half story house is two bays deep with six-over-six sash, shutters and a three-part window at the first story of the main facade. One chimney extends from the east roof slope near the rear of the house. There is a shed on dry laid stone with a single six-over-one window and a modern garage door. This building may be part of the late nineteenth century complex.

MHC #629 137 Woodland Road, ca. 1890s, rests on a stone foundation that has mortar and parging, has shingle siding and an asphalt roof. The two and one-half story house is three bays by four bays deep. Windows have six-over-one sash and narrow applied molding on the frame. Rafter ends are exposed and there is a flat verge board with pointed ends. There is a modest Colonial Revival open entrance porch at the sidehall entrance porch supported by round columns. On the south side there is an enclosed porch on mortared stone foundation. On the north side there is an enclosed entrance porch near the rear. Two rectangular stairhall windows with lattice muntins articulate part of the interior plan, namely the location of the stairs in relation to the entrance. The property has a large barn of molded cinder block with clapboards in the gable peak where there is a hay door with a diamond light cut into the vertical board door.

MHC #630 140 Woodland Road rests on a brick foundation with concrete under the side ell and porch. The ca. 1890s one and one-half story house has been covered with vinyl siding and windows also have been replaced with vinyl windows. This house displays a front gable form with a side gable ell. Hipped roof porches span the gable front and the side ell. The only remaining architectural details are the square columns with caps that support the full width porch of the main house and the boxed cornice and returns in the gable peak. The side ell has a full width screened porch with a solid balustrade, a wall dormer with two windows, and an exterior chimney on the south side.
