# Massachusetts Cultural Resource Information System

# FORM B – BUILDING

201 Parkerville Road (same as 3 Gilmore)

Name Ephriam Ward Jr.

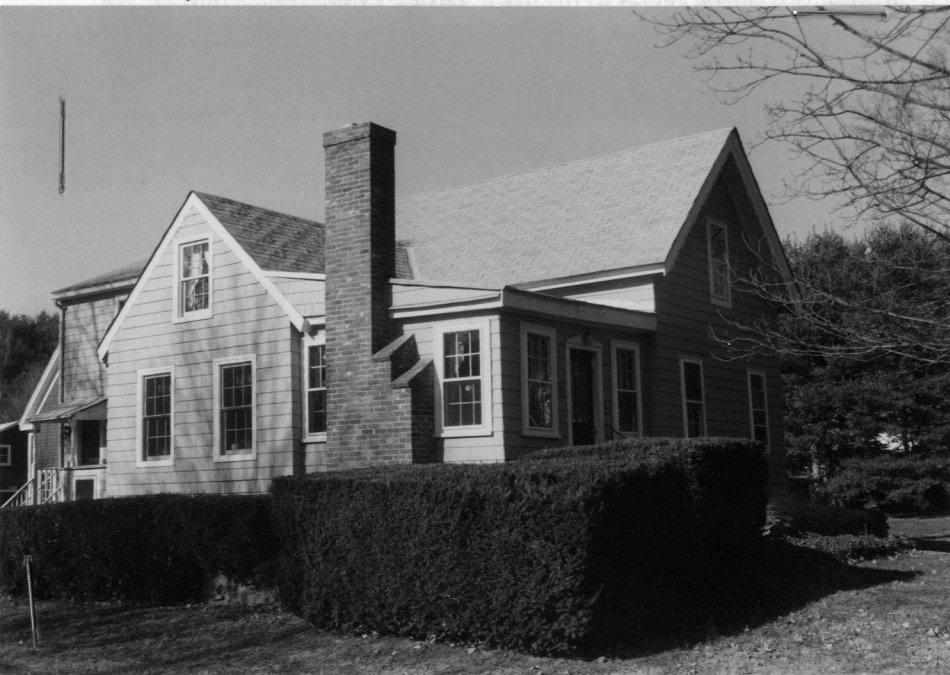
Although the one and one-half story gable front dwelling is substantially altered the relationship of buildings and the early L-plan of the plain house articulate the mid nineteenth century farming complex which has lost its farming landscape. The main house features a two-bay gable front with a single window in the peak all of six-over-six sash. The side ell or wing appears to have been added as it is on a brick foundation. The enclosed porch with exterior tall chimney on the south side is infill on concrete. The original house had a single story rear ell which was expanded on concrete foundation, a second story, and exterior stairs. All windows have six-over-six sash set in plain frames. Entrance doors are mid twentieth century and located in the front/east side of the enclosed porch and on the south side of the rear addition. The gable peak of the east side, facing Parkerville Road, has a decorative scalloped verge board with cutouts and quatrefoil design. The mid to late nineteenth century barn (MHC #659) remains with the gable end facing Gilmore Road, an overhead garage door in place of a centered barn door, a small hay door above and flanking 8/8 windows with the same in the gable peak. This barn is on a dry-laid stone foundation. The clapboard building retains wood corner posts and boxed cornice. Also on the property is a two-story hen house/barn (MHC #660) on a raised concrete foundation with carriage doors in the gable end/east side and a long low one-story five-bay shed behind with six-over-six sash. No doubt this was built when the property was a thriving poultry farm in the early 1900s. A four-bay garage of vertical board siding, probably of mid twentieth century construction is on the west side of the mid-nineteenth century barn.
